INDUSTRY ADVISORY BOARD – OWNERS MEETING

Sustainable Bridge Management

COST ACTION TU1406

22nd November 2018 Bergisch Gladbach, Germany

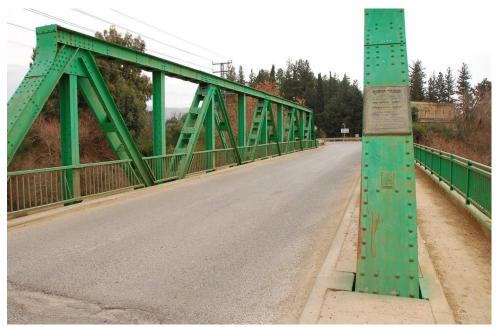
- Built 1956
- 36 meter single-span half-through steel truss bridge
- Riveted steel plates, angles and U shape steel profiles
- reinforced concrete slab
- The bridge carries road no. 9779 across the Jordan river between north of Galilee and the Golan heights

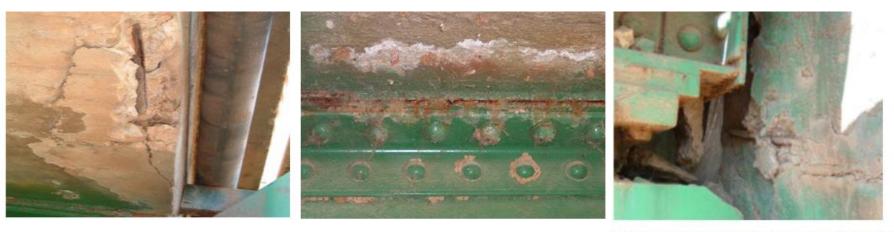
Technical condition of the bridge: Concrete slab and Abutments defects

slab edge (typical along the edges)

Fig. 27 Spalling and delaminations along the deck Fig. 28 Corrosion at the connection between transverse Fig. 32 damage to closing wall near supports at massive abutment girder and the deck slab with efflorescence due to water penetrating in between the girder upper

Fig. 30 concrete spalling at massive abutments

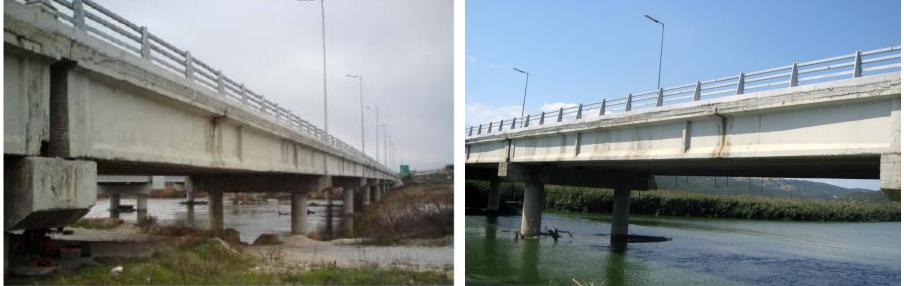
STRYMONAS RIVER BRIDGE SELECTED FOR GIRDER BEAM USE CASE

The Strymonas river bridge is a 8 span bridge, built by pre-stressed concrete, founded on the river bed of the Strymonas river, with multi column piers through piles.

The total length of the bridge is 240m, its pavement width -including sidewalks-is 12.00 m, providing two traffic lanes.

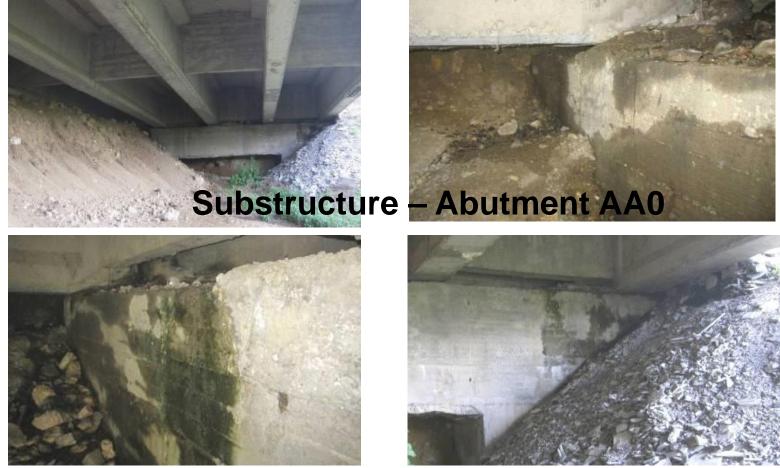
DEFECTS DETECTED DURING INSPECTIONS

- Wet spots / moisture or wetting areas mainly at the ends of the abutment due to the incapacity of the superstructure's expansion joint.
- Light efflorescence on the surface of the concrete.

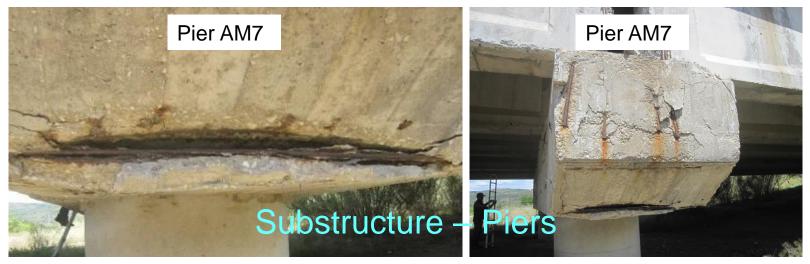
Wetting of concrete's surfaces, heavy spalling of concrete, exposed and totally corroded steel bars.

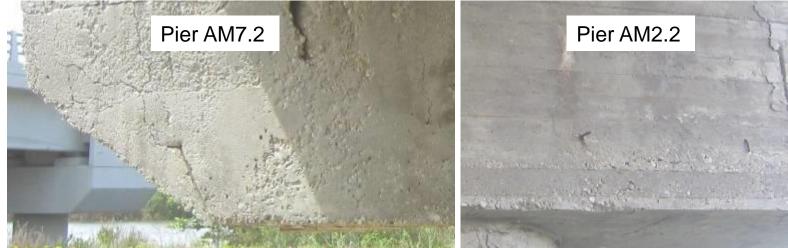
Areas with voids all over the surface of piers.
